# **ISS Fiber Optic Failure Investigation**

## **Root Cause Report**

**August 1, 2000**

**ISS Fiber Root Cause Investigation Team  
Lead organization NASA GSFC  
Sponsored by: NASA JSC and the Boeing Company**

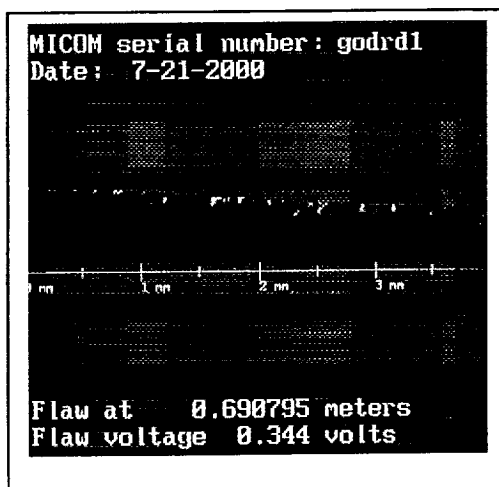
**Figure 17 Debris-Laden Fiber**

A fiber inspection system, built by the US Army Aviation & Missile Command for their own internal use, was used to try to inspect for 10  $\mu\text{m}$  sized features in the polyimide surface that might indicate the presence of the bubble feature that has been consistently associated with "rocket engine" defects and low strength breaks. The system uses an infrared detector and looks for signal scatter off of the surface at feature locations. The feature is described with respect to the voltage of the returned scattered signal. When a feature is found that corresponds to a minimum signal voltage, the system takes a picture of the corresponding location. The inspection system is very sensitive to any surface feature, especially contamination such as lint and dust (Figure 17). A lint free dust capture stage was arranged around the fiber and the inspection was continued. Figure 18 shows the image of a debris-free fiber with polyimide surface features.

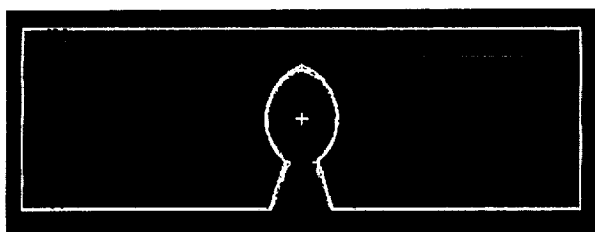
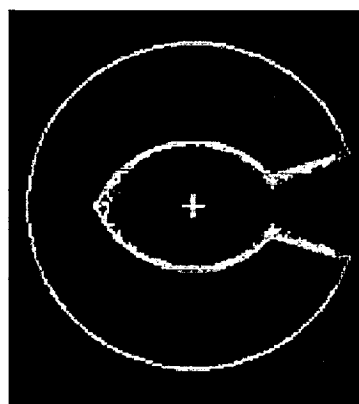
**Figure 24** Model of "Rocket Engine" Defect

reaction creates heat in the forward direction, adding to the force of the eruption. The ejected material is  $\text{SiO}_2$  and  $\text{GeO}_2$ . The escaped fluoride gases, in the presence of water, will be in equilibrium with  $\text{SiO}_3\text{H}_2$ ,  $\text{GeO}_2$  and  $\text{HF}$ ; this is essentially the reverse of the reaction proceeding from the point of the protonation of the glass surface. This regenerates the  $\text{HF}$  in a catalytic manner. There are some side reactions that may slightly decrease the active  $\text{HF}$  concentration; however, the  $\text{HF}$  is recoverable for reaction with the glass until the  $\text{HF}$  is physically removed from the system. The  $\text{SiO}_2$  precipitates as a silica gel when the water around it evaporates giving rise to spherical shapes surrounding the hole. The spheres are silica in a hydration state, but not vitreous glass. The same occurs for the  $\text{GeO}_2$ , except that it forms a shard-like crystalline structure. The reaction conserves mass and energy.

The shape of the cup in the cladding area reflects the speed at which the reaction occurs in the pure silica material and its increasing speed in the Ge rich material. A FEA model was constructed for the BF04515 fiber to understand the internal stresses in the glass with a "rocket engine" defect when the fiber is under a 25% strain (Figure 24a through c). Figure 25a through c shows that the internal stress in the fiber in this case rises by a factor of three over a section, which is experiencing the same amount of strain with no "rocket-engine" defect.

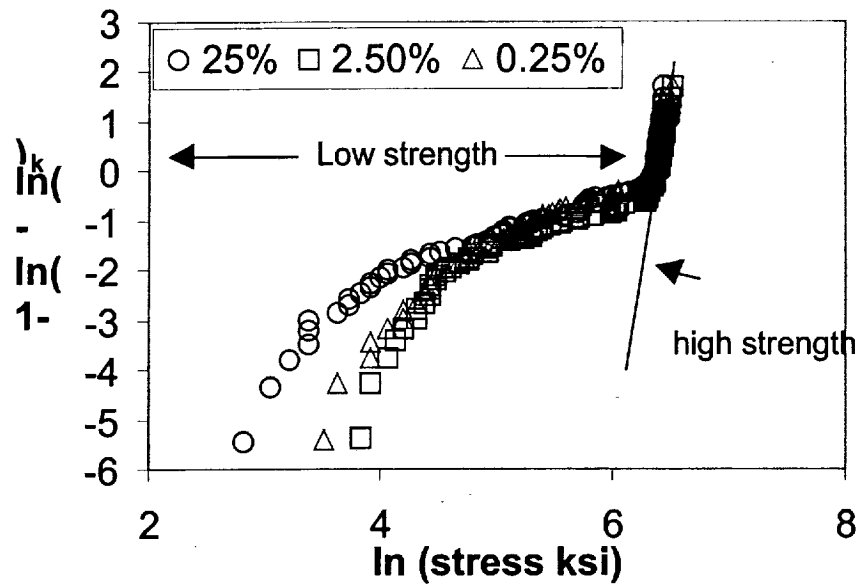
Figure 30 Weibull Plot for Strength of 1996 Vintage Cable from Several Cable Reels

The results of the initial strength tests are shown in the Weibull plots in Figures 30 and 31. Prior analysis showed that the fiber shipped by Lucent-SFT was proof tested to 141 kpsi (@ 3.36 lbs). The cable specification requirement is for a fiber strength of 200 kpsi (@ 4.76 lbs). Lindholm, et. al., report strengths of 500 kpsi (11.90 lbs) and higher for four carbon coated fibers they have manufactured. The plots showed the high strength of the cabled fiber to be around 252 kpsi (6 lbs) and the low strength to go as low as 126 kpsi (3 lbs).

The inspections found that defects were present in large numbers that were either small etch pits at the surface of the cladding or corrosion sites in the same location. The knees in the Weibull plots, an associated slopes, show that there is more than one dominant failure mode. According to the physics of glass, the order of the curves should show the black circles (highest strain rate) located to the right of the other curves, not to the left. Figure 31 shows that the distribution of low strength breaks among the reels was significantly different even for reels with the same date of manufacture. These distributions could not be used to quantify the expected life of the cable using classical methods.
